218 Kensington Road

Ledge School

1985 Townwide Historic and Architectural Survey of Berlin, Connecticut. Survey # 068

HISTORIC RESOURCES INVENTORY
BUILDING AND STRUCTURES
 HIST-6 NEW 5/77

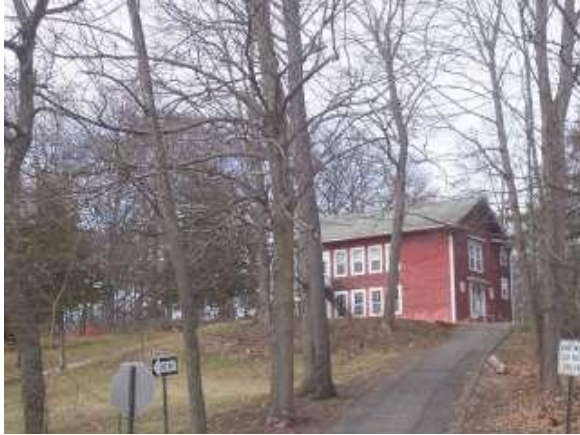
3rd school building at this location

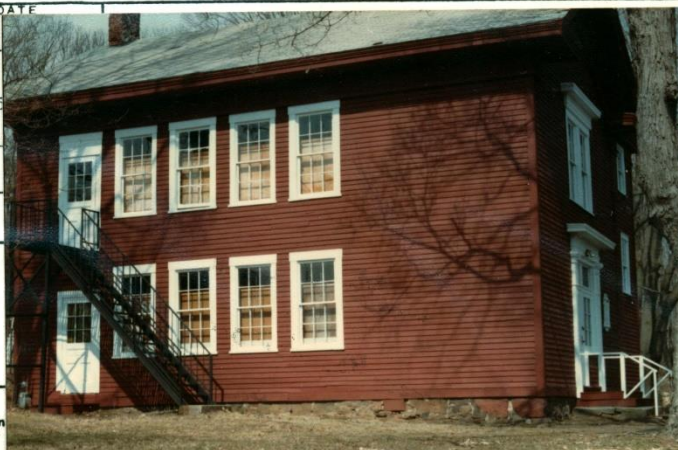
HRC	1
COMPILED BY	VIEW	NEGATIVE ON FILE
	NW	A0A
COMPILED BY	NAME	1
	<p>Historic Resource Consultants The Colt Armory 65 Van Dyke Avenue Hartford, Connecticut 06106</p>

DESCRIPTION (Continued)	17. OTHER NOTABLE FEATURES OF BUILDING OR SITE (interior and/or exterior)	
	<p>The facade of the Ledge School is treated as a single large bay. The trabeated entry has a glazed transom and a fixed six-pane sidelight to the right. The entry has square chamfered pilasters, a wide entablature with a central molding, and a prominent molded cap. Above is a paired window fitted with a similar entablature and cap. The heavily molded main roof cornice shows a partial return at the gable ends. At the right side of the facade is a rectangular stair tower. Side elevation windows are grouped near the rear of the building. There is a modern steel fire stair at the rear of the left elevation. The rear elevation shows a blank wall with a partial return of the main roof cornice. Windows on all elevations are generally fitted with oversized 6-over-6 sash.</p>	
SIGNIFICANCE	18. ARCHITECT	BUILDER
